THE HOME INSPECTION REPORT

07070202B - [REDACTED]

[REDACTED] PA 19063

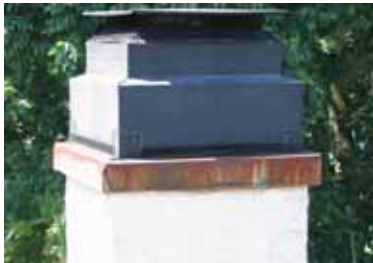
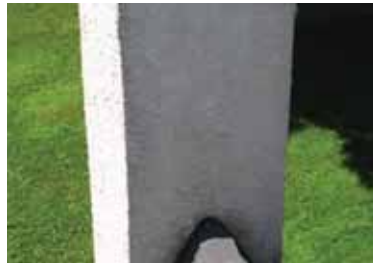
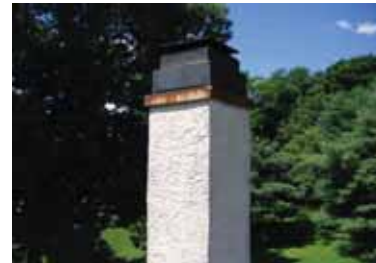
There is a pre-fabricated chimney system.

The chimney exterior sides appear to be in acceptable condition.

The metal termination cap on the chimney stack is rusted. Staining. We do not want water penetration down the stack interior. Correction and further evaluation is recommended.

There is no kickout flashing used at the sides of the chimney stack, where the ends of the gutters meet the stack's sides. Correction by a professional roofer is recommended. This may be allowing water draining off the roof to miss the gutter and drain behind the siding exterior covering. If not corrected, this could lead to water penetration and damage inside the chimney wall. Kickouts also prevent water from streaking down the siding exterior covering and causing water stains. We recommend a kickout flashing - an angled piece of metal secured to the roof - to be installed near the bottom of the roof, to direct water into the gutter and away from this siding area. Correction and further evaluation is recommended.

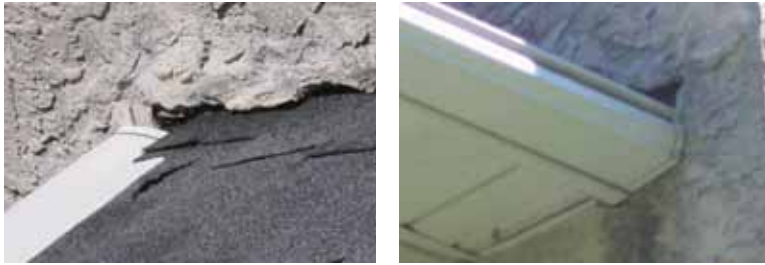
An open gap at the flashing area - prone to water penetration. Exposed mesh.

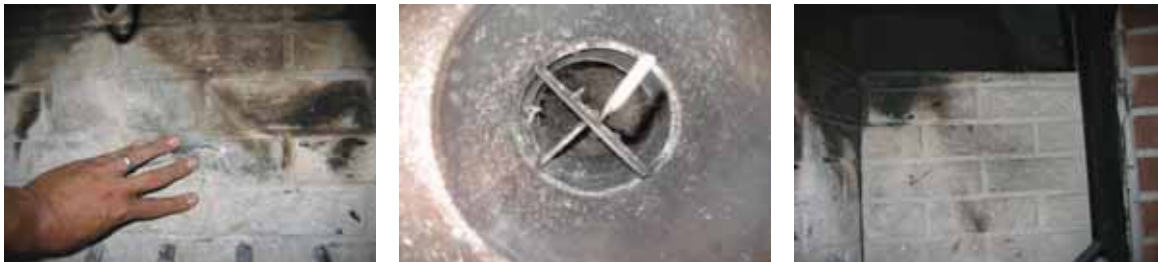
There are visible hair-line cracks at the fireplace interior refractory panel. Does not appear to be a major breach in the firewall panel. Monitoring the crack is needed. If the crack opens up anymore, then heat would pass through the barrier and damage the fireplace unit, and also may become a fire hazard.

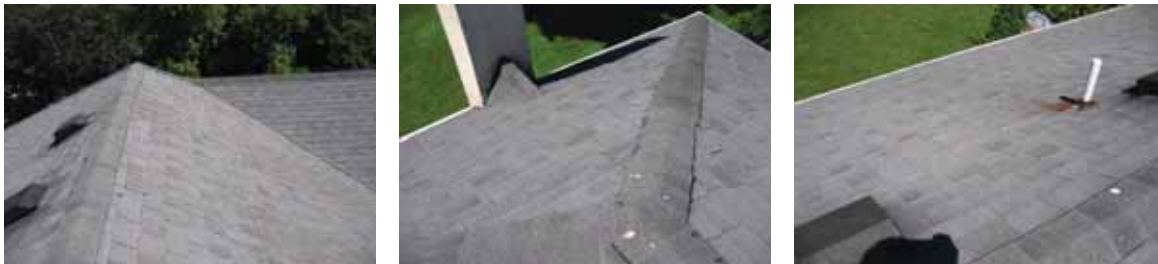
The shingles are comprised of asphalt or fiberglass materials impregnated with mineral granules that are designed to deflect the deteriorating ultra-violet rays of the sun. The most common of these roofs are warranted by manufacturers to last from fifteen to twenty-five years. The actual service life of the roof will vary, depending on a number of interrelated factors including the quality of the material and the method of installation. Regular maintenance will certainly extend the life of any roof.

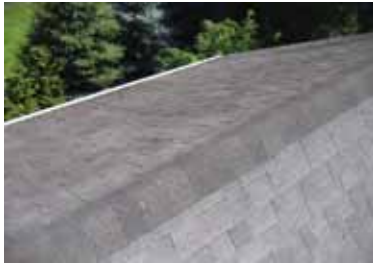
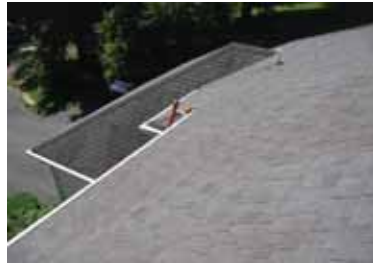
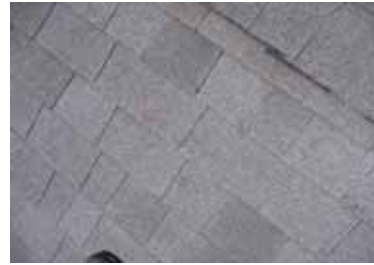
The roof is steep in areas, and I'm unable to walk upon all of them.

The asphalt shingle roof covering appears to be in good, functional condition. Considering its older age. This is not a brand new roof. There were no major material defects. No major cracked, damaged, or missing shingles. Good.

There is visible erosion of the granular surface of the asphalt shingles. Indicating its older age. May start to deteriorate quickly. Replacement of the shingles is in the near future.

There are roofing nails that are backing out and popping through the shingle tabs. These are water entry points. Located on the front side of the roof. Further inspection and correction by a professional roofer is recommended.

Budgeting for a new roof soon is recommended.

Minor repairs are needed at the roof. Correction and further evaluation by a professional roofer is recommended.

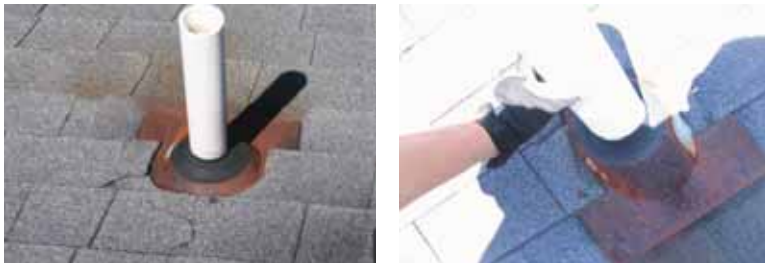
The flashing around the vent stacks coming through the roof appear to be in good condition. Good.

A representative number of wall flashing was inspected. The flashing where the roof meets the house wall is visible. Good.

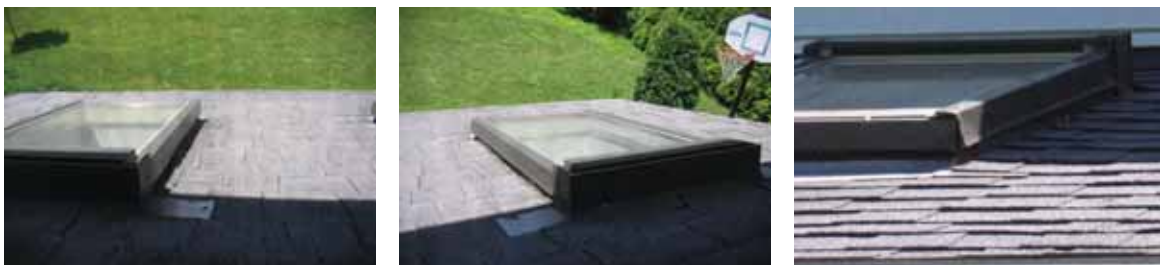
The roof has skylights. Skylights are notoriously problematic and a common point of leaks. The skylights appear to be in good shape. However, it will be important to keep the area around them clean and to monitor them for evidence of leaks during heavy rains and winter snow melts.

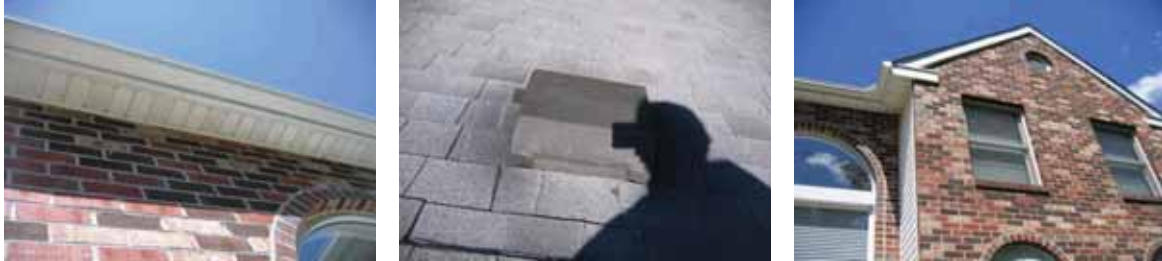
There are soffit vents installed at the eaves.

There are gable vents installed on the sides of the house to ventilate the attic space.

There are passive roof vents installed on the roof.

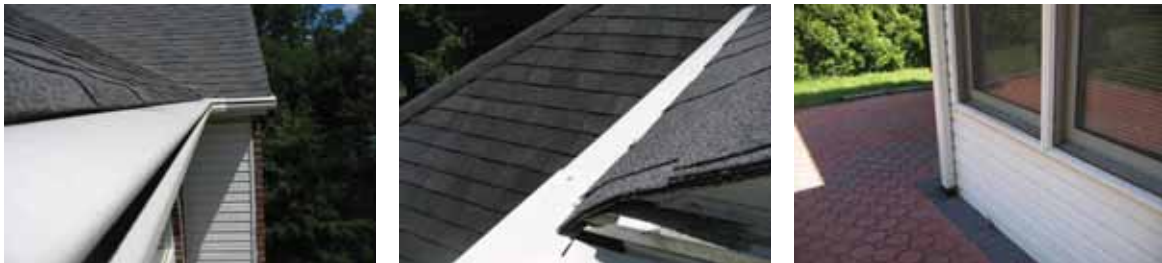
The gutters and downspouts appear to be in functional condition. Good.

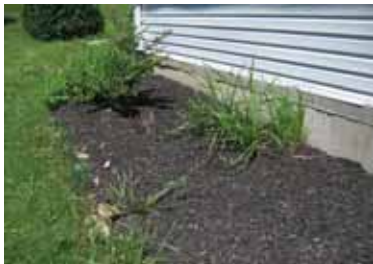
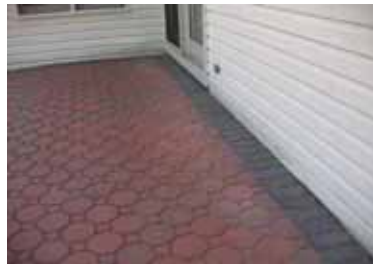
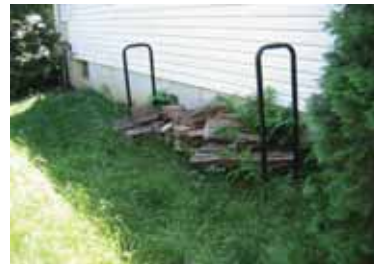
The general grading around the house foundation perimeter appears functional. Good. Ideally the grading should slope about 6 inches over the first 10 feet away from the house foundation. Monitoring during a rainstorm is recommended.

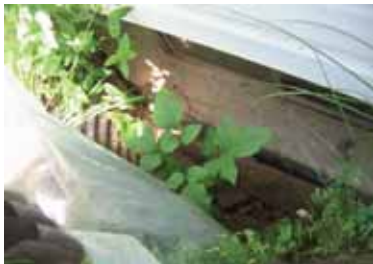
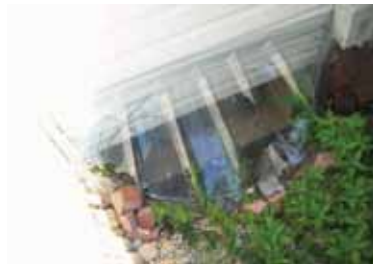
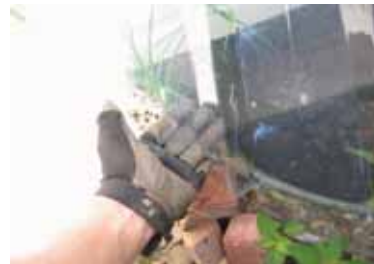
The window wells appear functional.

Cover is cracked or damaged.

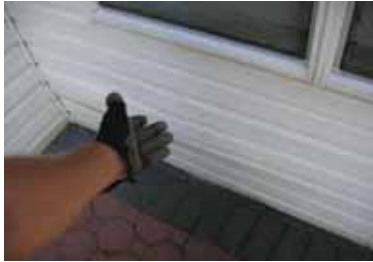
There's a large bulge in the vinyl siding. Located at the back, right inside-corner area of the house. Correction and further inspection is recommended.

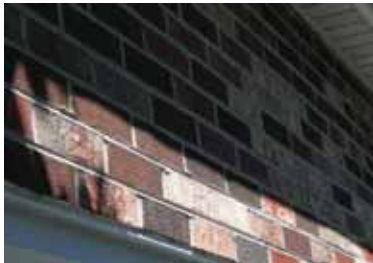
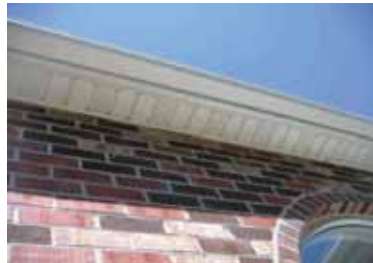
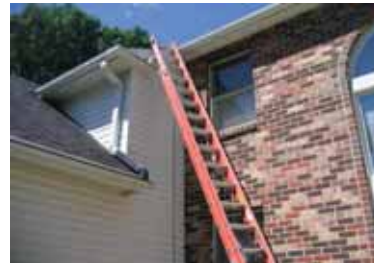
I moved around the structure exterior several times, inspecting the brick exterior of the house. Checked for loose bricks or mortar joints, missing pieces, damaged sections, deterioration, or failure. No major defects observed. The brick exterior appears to be in functional condition. Good.

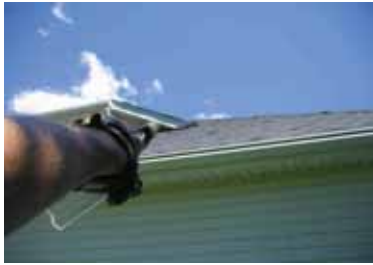
There is loose capping. Falling off the house. At rake board area. Left-side of the garage roof. Repairs needed.

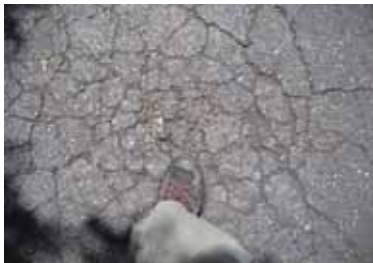
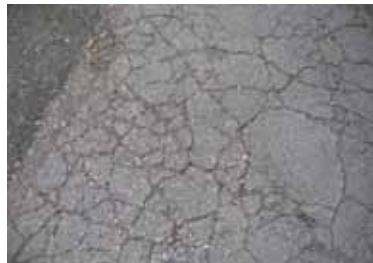
The asphalt material in the driveway is damaged near the street. Major cracking. Deterioration. Grass growth. Professional repairs needed. A large section to replace may be recommended by the asphalt professional.

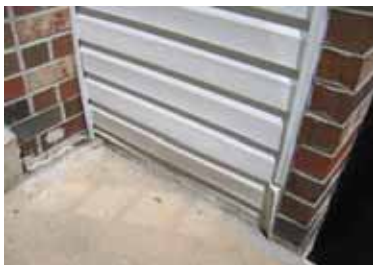
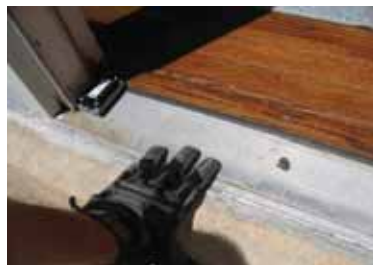
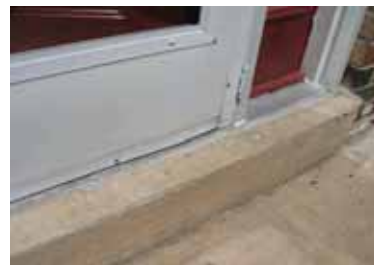
Settlement of the front patio.

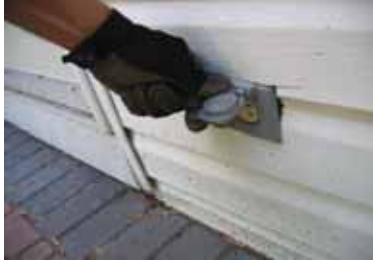
The exterior receptacles that were tested are functional and include ground-fault protection. Good.

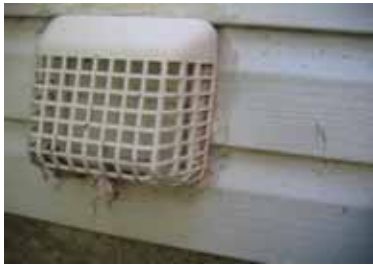
The dryer has a screen installed on its exhaust hood. Prone to clogging and producing fire hazards. Not allowed by standards. Correction recommended.

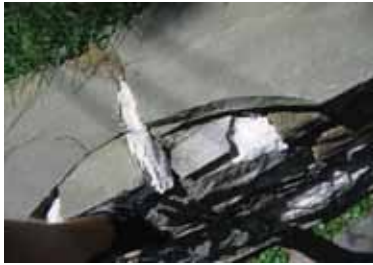
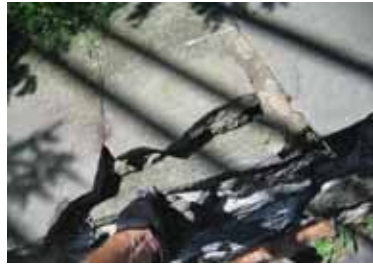
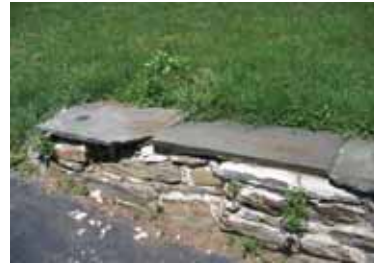
Many areas of the wall have missing stone pieces. Has been patched in most areas.

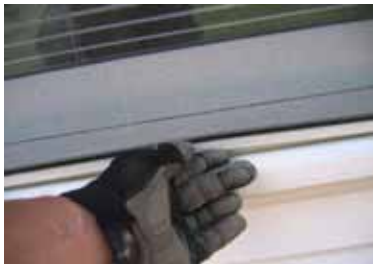
A few of the window screens are dented.

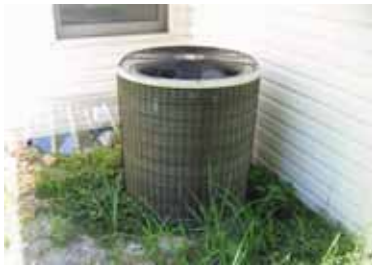
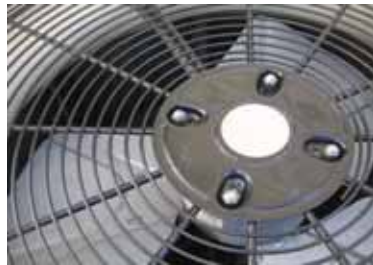
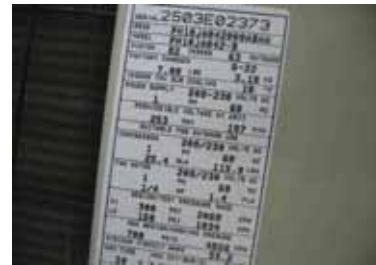
There is one heat pump system

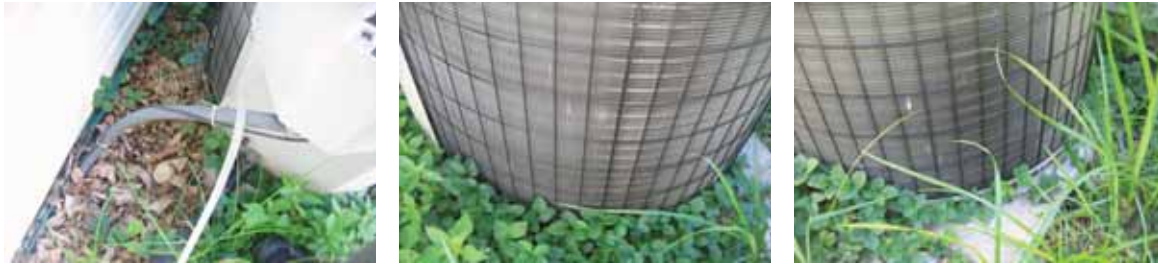
The exterior condenser unit appears level.

You need to monitor the way the unit rests. Sometimes a unit can all by itself start to tilt off-level. A unit should be no more than 2 inches off level, measuring from one corner to the opposite corner of the unit.

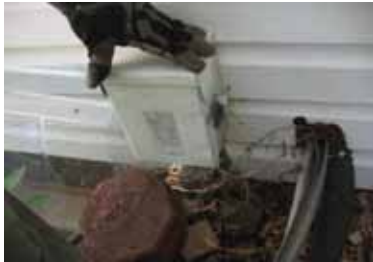
There is an electrical disconnect near the exterior condenser unit.

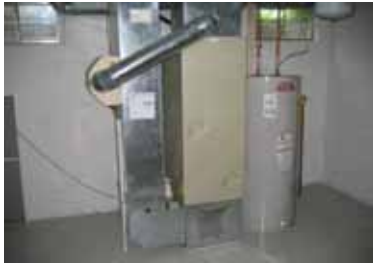
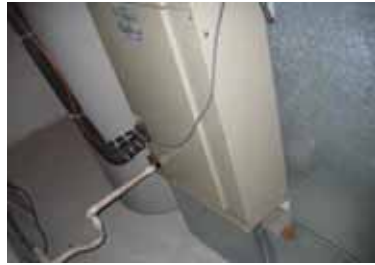
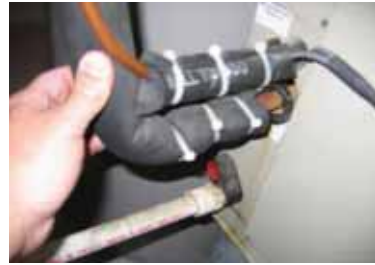
There is an interior evaporator unit located in the basement.

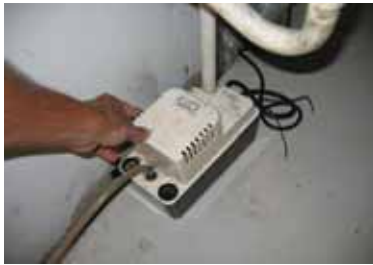
The condensation drains from the unit to a condensate pump. Appears to be functional.

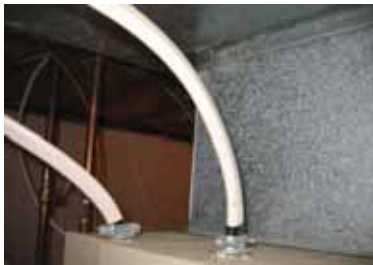
There is an electric coil at the heat pump system.

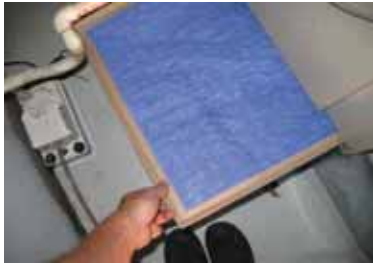
The air filter is disposable and clean. Check every 30 days. Replace when necessary.

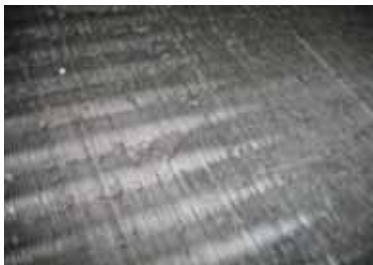
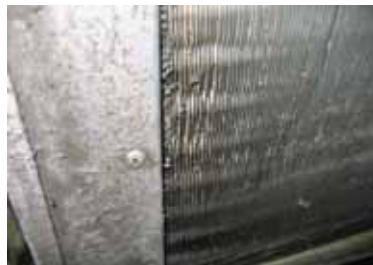
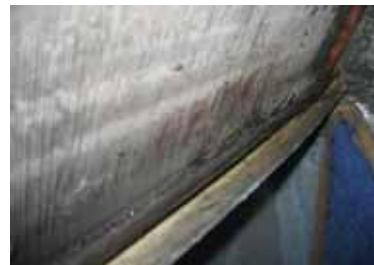
There is condensate water leaking from the coil tray - cleaning needed.

There is black stuff on the visible evaporator coil fins - cleaning needed.

Recommend having the heat pump system cleaned, inspected, and serviced by an HVAC professional.

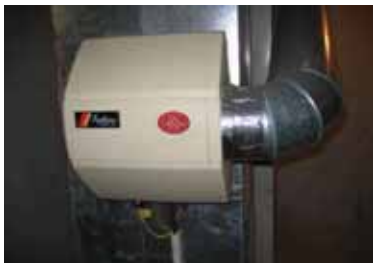
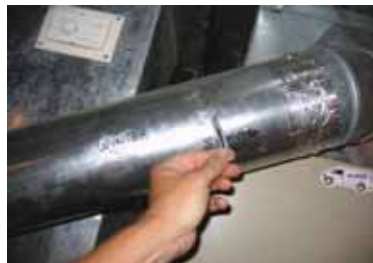
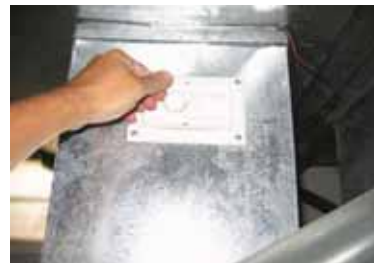
Humidifier

Py-pass humidifiers need to be serviced and cleaned every year. In the wintertime, when not in use, turn off the water valve, shut the damper closed, and turn off the control.

The humidifier appears functional.

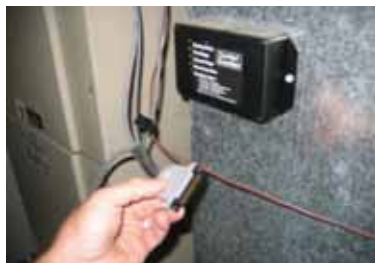
Observation

There's an alarm on the system. Presently unplugged. Ask seller.

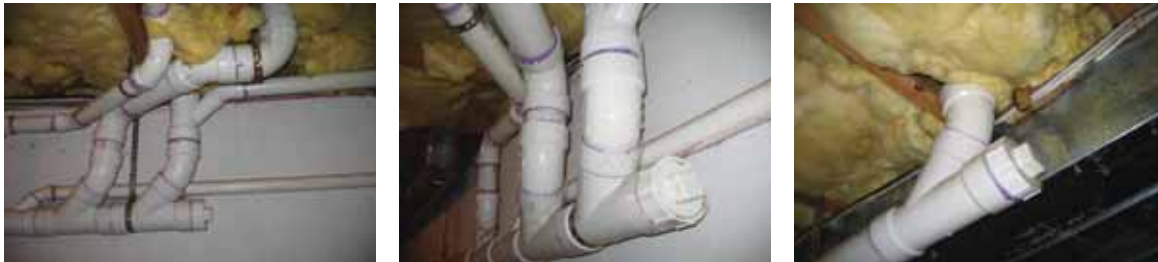
Drain Waste Vent Pipes Type of Material

Visible portions of the drainpipes are of PVC, poly vinyl chloride. Very commonly used material.

Not all of the drain pipes were readily visible. Much of the pipes are inside the walls.

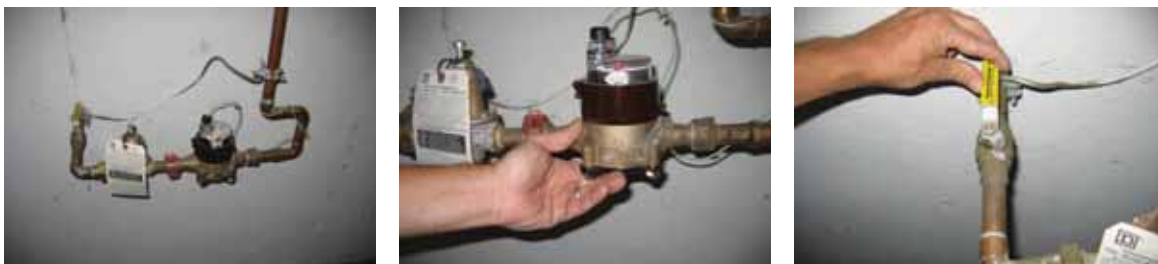
Public Water Supply Main Water Shut-off Valve

The main water shut-off valve is located in the basement.

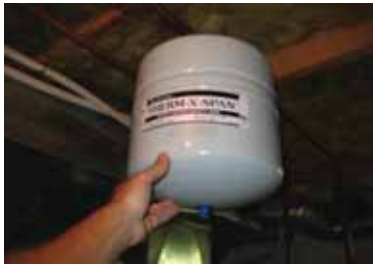
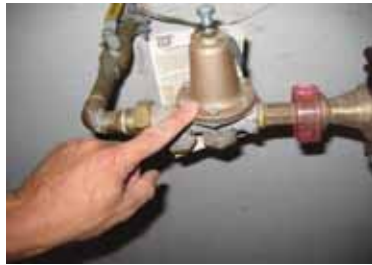
Check Valve & Expansion Tank

The water line has an expansion tank installed on it. There is a back-flow pressure check-valve installed on the water supply line coming into the house. This back-flow valve prevents water from flowing back out to the street, and makes the plumbing system a closed water system. When the water heater makes hot water, the water in the system expands. The expansion of the warm water increases the pressure on the homes water pipes. The expansion tank absorbs the extra pressure. The action of the expansion tank reduces knocking of the pipes and wear and tear on the faucets and shut-off valves in the home. Good.

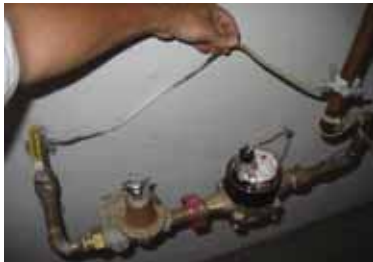
Jumper Cable at Meter

- There is a jumper cable installed over the water meter - Good.
- See Attached Illustration 4

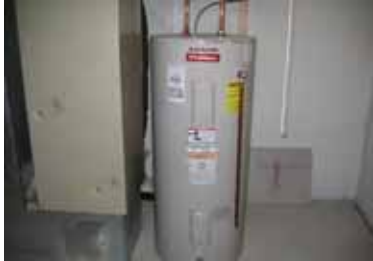
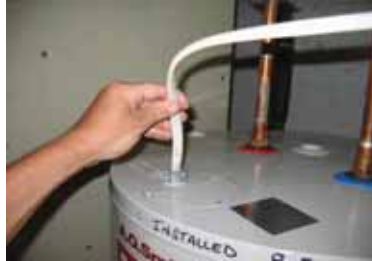
An electric hot water tank is installed. Electric hot water tanks can be expected to last at least as long as their warranty, or from five to eight years, but they will generally last longer. However, few of them last longer than fifteen or twenty years and many eventually leak.

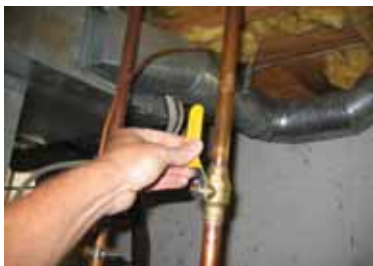
Water Shut-Off Valve & Connectors

The water shut-off valve to the water heater tank is installed. Not leaking. Good. This valve turns off the cold water supply to the tank.

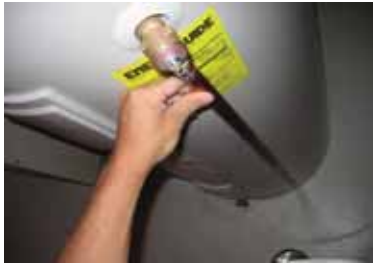
Relief Valve & Discharge Pipe *MONITORING RECOMMENDED:*

The water heater is equipped with a pressure-temperature relief valve. The pipe is extended to the floor. For safety. Good.

The pressure temperature valve is a safety device that opens up and releases pressure (and hot scalding water) from the tank. This opening of the valve would happen if there's an excessive build-up of pressure or extreme temperatures in the water tank. The end of the pipe should be conspicuous, so that you can easily notice if it is leaking or discharging water. If the valve is discharging, something is wrong, turn off the water valve, turn off the power, and call a plumber. All hot-water-distribution pipe and tubing shall have a minimum pressure rating of 100 psi at 180°F.

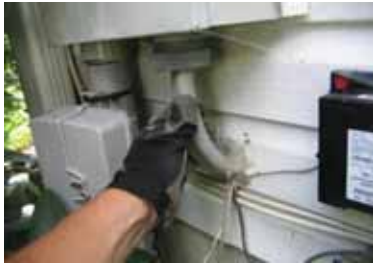
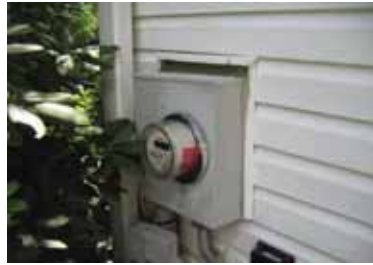
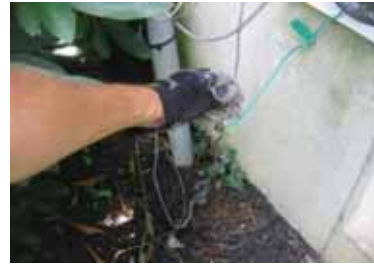
Number of Meters & Location

There is one electric meter.

The meter is located at the right-side of the house.

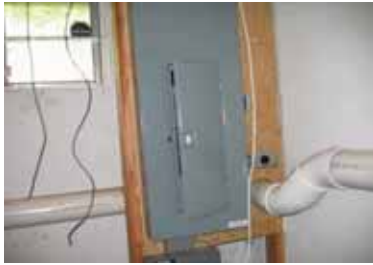
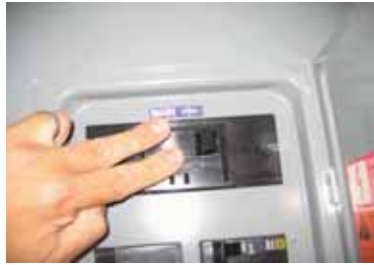
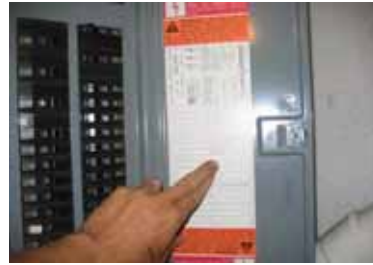
Location of Panel

The main panel is located in the basement.

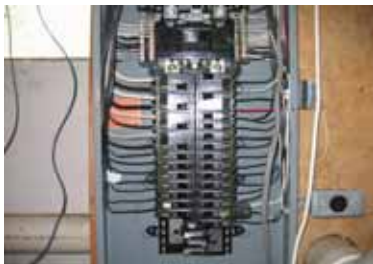
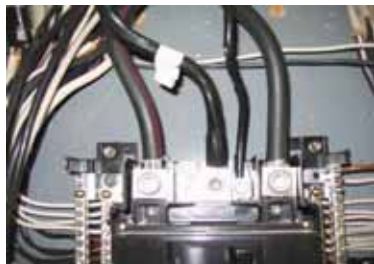
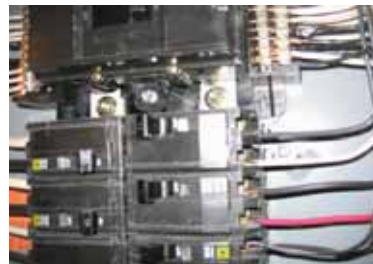
Wiring Type

Modern Romex wiring is visible. Good.

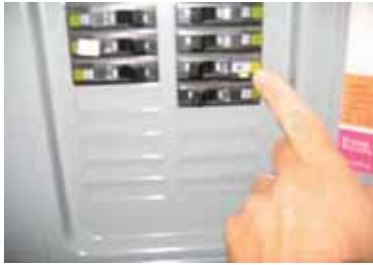
The ground-fault circuit interrupter breaker at the panel labeled "whirlpool tub" was manually tested. Tested functional. Good.

The system does not include arc-fault circuit interrupters, which effective January 1st, 2002, are mandated by the national electrical code to protect 15 and 20 amp branch circuits serving bedrooms in new construction. This is not a new home, so simply consider the benefit of installing them.

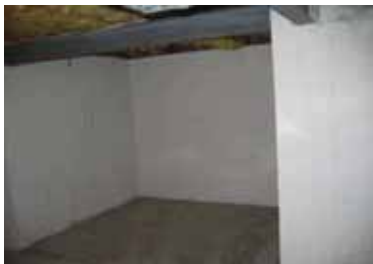
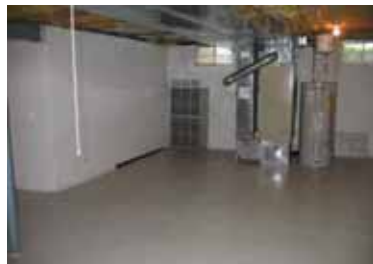
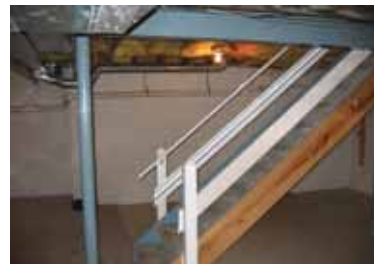
Basement For Your Information

This residence has a basement. We try to enter and inspect all accessible areas, looking for any evidence of structural material defects. We look for cracks, but those that are less than 1/4" and which do not exhibit any vertical or horizontal displacement are generally not regarded as being material structural defects. We look for signs of water penetration too, but please consult the seller's disclosure.

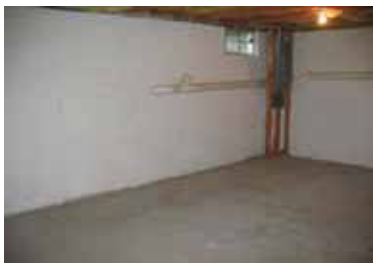
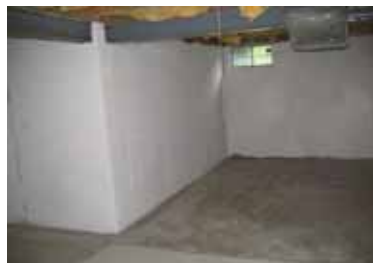
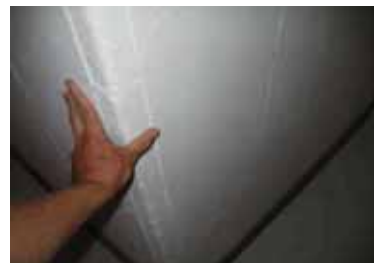
Basement Restrictions

We do all we can to see everything in the unfinished basement. There are restrictions to the inspection though. Including but not limited to the electrical wires, pipes, storage, ductwork, insulation, floor coverings, etc.

The inspection of the floor structure is restricted by the insulation. Limited visual access. I'll move and probe a random sample of the insulation. However, much of the electrical wires, water and sewer pipes, heating ducts/pipes, and floor structure can not be seen. There may be components above the insulation that need improving or correcting that the inspector can not see.

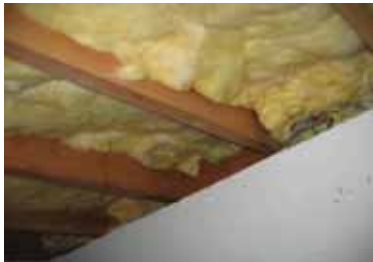
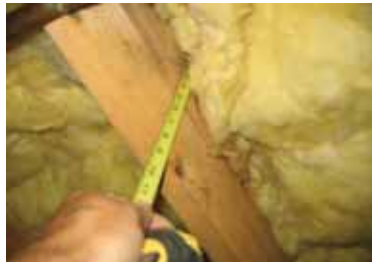
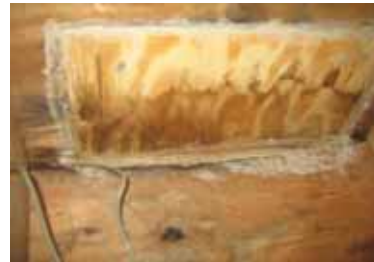
Floor Type and Condition

There are water stains in areas on the floor under the entry door. Not actively wet. Possible water problems in the past. Ask seller.

The floor joists are made of dimensional wood lumber - 2x10s.

I walked around, probed, checked the floor as best as I could. No material defects apparent. No major structural defects found. Recommend asking the seller if any repairs have been made to the floor structure in the past.

There have been structural repairs to floor under entry door. Ask seller about prior repairs and possible water penetration problems.

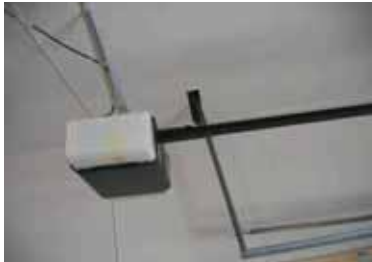
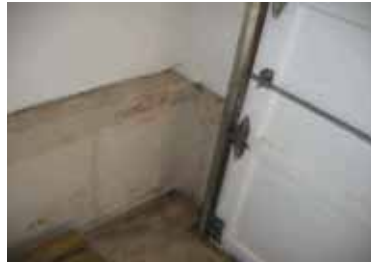
Neither opener is equipped with infra-red sensors that enable the door to auto-reverse, which is a desirable safety feature.

Each garage door opener is hooked-up to a GFCI (ground fault). Located in 2nd floor bathroom. The GFCI may trip off by mistake, and shut-down both opener machines. An opener should be on its own dedicated electric circuit.

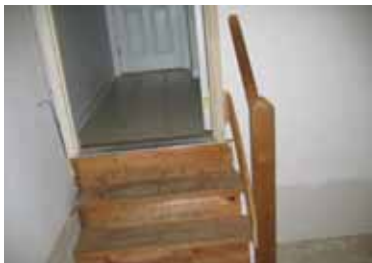
The top step at the door between the laundry and the garage is an inch higher than the other steps. Trip hazard.

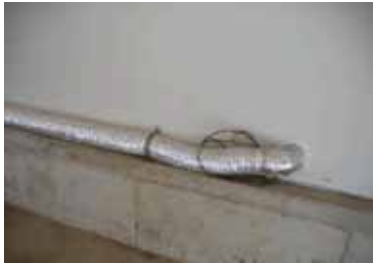
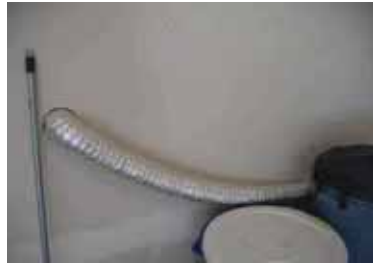
The dryer vent that penetrates the firewall appears to be of a paper-thin foil. Not covered with a fire-rated material (drywall). Which violates the integrity of the firewall between the house and the garage.

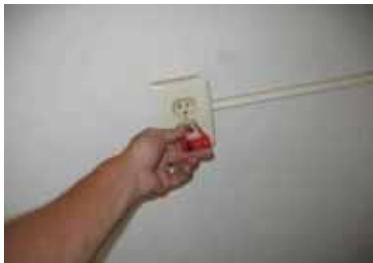
Receptacles

The receptacles that were tested are functional, and include ground-fault protection. Good.

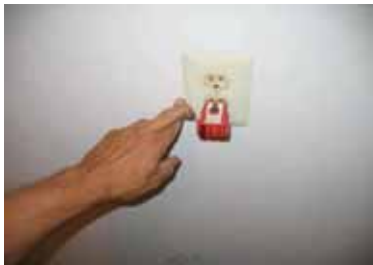
Missing GFCI protection at the electric receptacles near the tub.

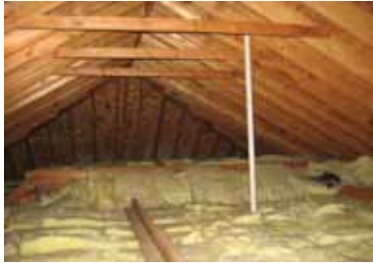
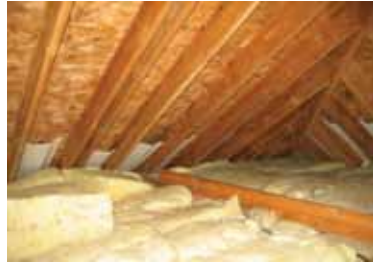
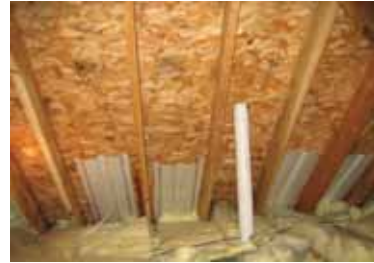
Method of Evaluation

We inspected the attic by entering it. But there is no flooring, and the insulation is covering the joists. I am unable to safely move all around the attic space completely. Inspection restrictions.

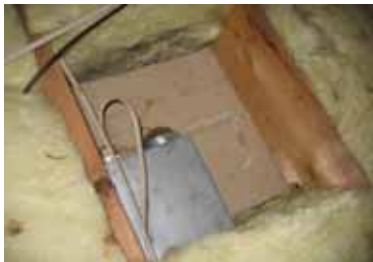
The bathroom fan exhausts into the attic. This has not been properly installed. The fan should be vented to the outside properly. Either through the roof or through an outside wall. Not to the soffit vent at the eaves of the roof. Currently the fan vents moisture into the attic space. This moisture can reduce the R-value of the insulation. The moisture can contribute to mold and mildew growth on the underside of the roof sheathing. Correction of the bath fan which is exhausting into the attic is recommended.

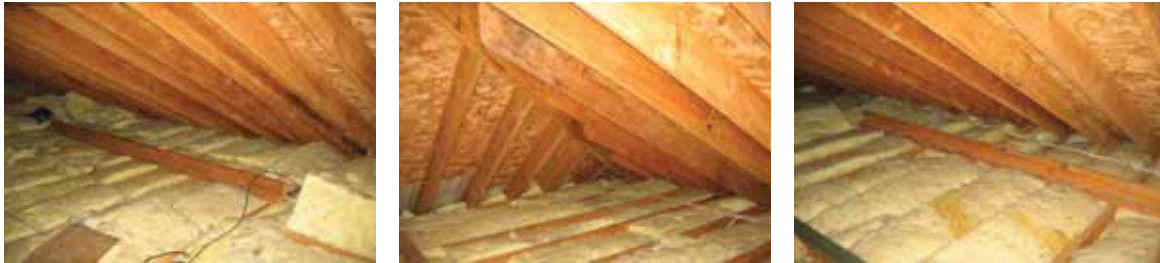
Insulation

Fiberglass batt insulation is installed. Fiberglass is a man-made product that is composed of natural ingredients such as sand and recycled products such as window glass and bottles. The ingredients are melted and spun to create small strands of fiberglass that together form "glass wool". Fiberglass insulation has been used since the 1930s and is now the most widely used home insulator.

Estimated 9 to 10 inches thick. Good. Meets the standard that requires about 10 inches thick or an R-30 value of insulation installed on the attic floor area.

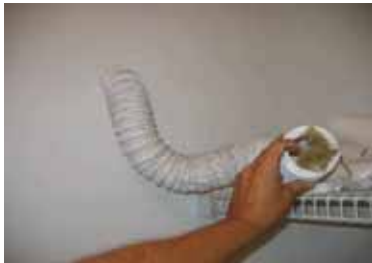
The exhaust fan is working, but it is exhausting into the laundry room. You may wish to have it redirected.

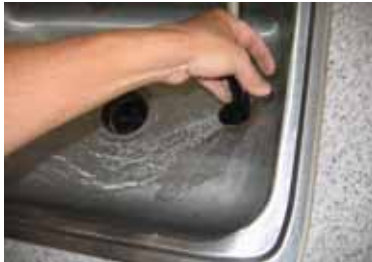
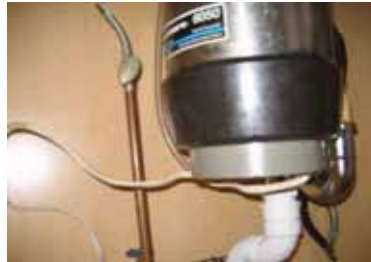
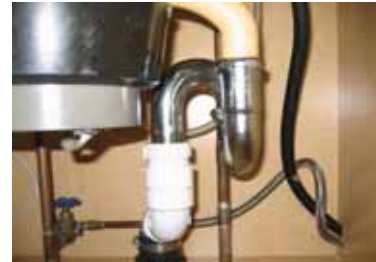
Faucet

The sink faucet is functional. No active leaks seen.

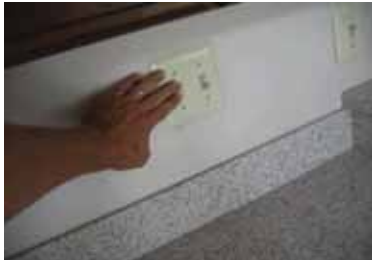
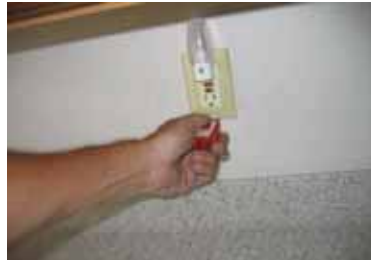
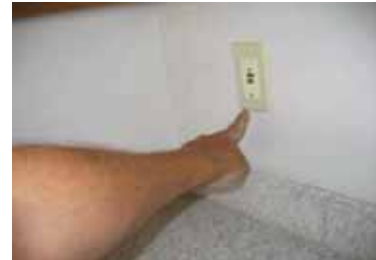
Receptacles and GFCI

The visible counter receptacles that were tested are functional and include ground-fault protection. Good.

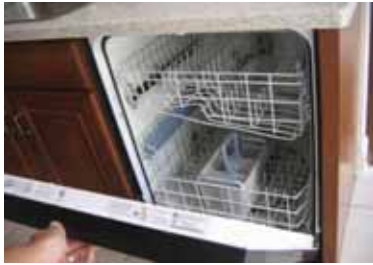
Dishwasher

Ran a short cycle with no leaks. (This is no guarantee against future problems.)

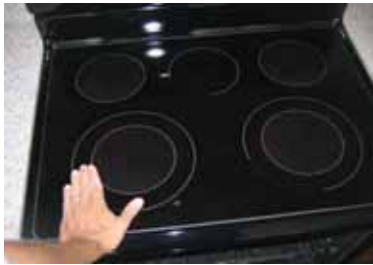
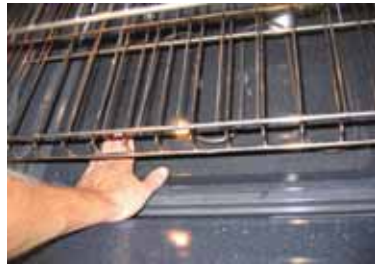
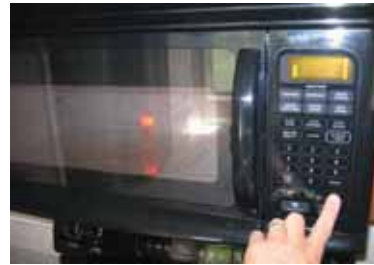
Electric Cooktop

Electric stove elements are functional. Turned on and warmed up. Good.

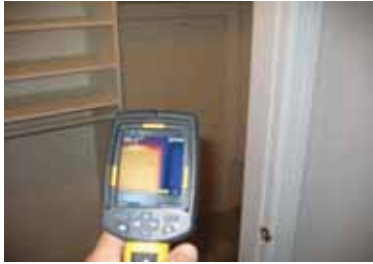
Missing or little insulation at the attic access panel at the wall of the master bedroom closet. Energy loss area.

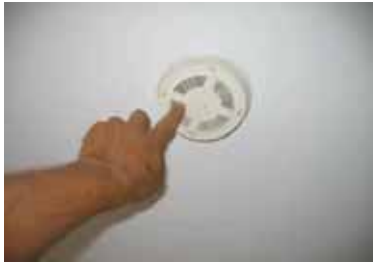
Ideally there should be smoke detectors installed on every floor, including the basement and the attic space, inside every bedroom, and in the hallway outside the bedrooms. The detectors should be hard-wired with battery back-up.

The smoke detectors are hard-wired only, without battery back-up installed. If power is interrupted, the detectors will not operate. Replacements recommended.

Recommend installing new detectors throughout the house. For your own peace of mind.

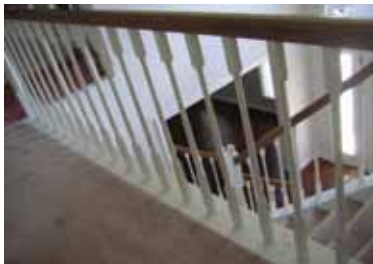
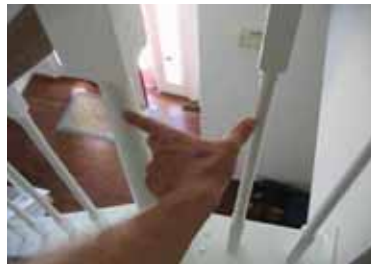
- See Attached Illustration 7

The balusters in the stair rails are more than four-inches apart and are not child safe. Therefore, you may wish to add a protective barrier.
