## THE HOME INSPECTION REPORT

**07070501B - Norman** [REDACTED]

[REDACTED] **Wayne, PA 19087**

**7/5/2007 8:00 am to 11:00 am**

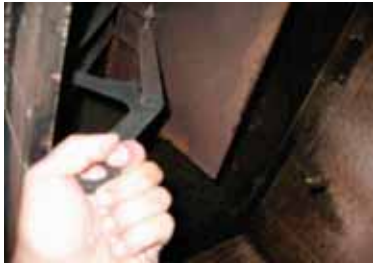
There is rust and corrosion visible. The rust is located on top of the fireplace, above the damper area. Visible through the screened mesh that is located above the fireplace opening in the front. There are water streaks here too. This may have been caused by the previous water problems with the fireplace and cap.

A certified chimney professional is recommended to inspect the chimney stack, including the flue components, and the rust/corroion area.

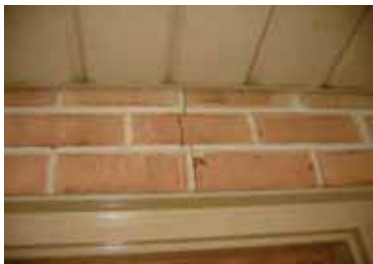
There's a crack in the brick, above the entry door.

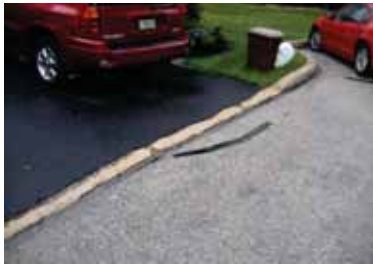
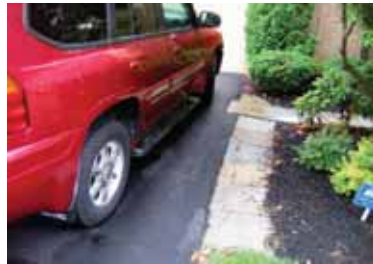
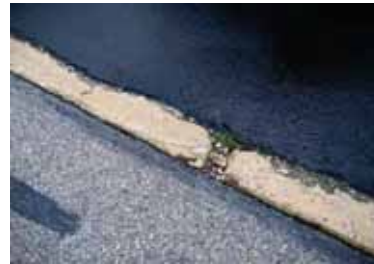
The driveway appears functional. Concrete curb is damaged.

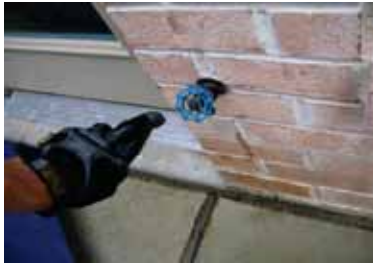
The faucet is not frost-free. Consider replacing the faucet with frost-free hose bibs. To prevent freeze-burst problems in the winter. Or be sure remove the hoses and drain the faucets before winter, to prevent freezing and bursting problems.

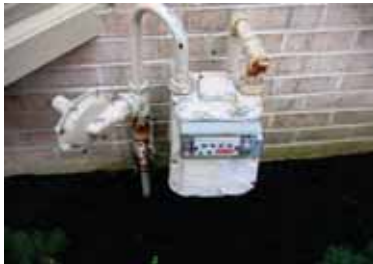
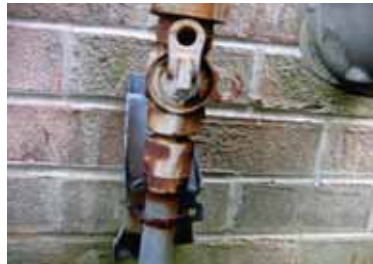
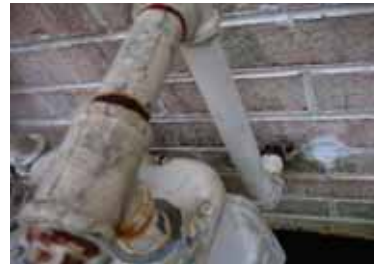
The main gas shut-off valve is located near the gas meter at the side of the house.

The gas meter has some surface rust on it.

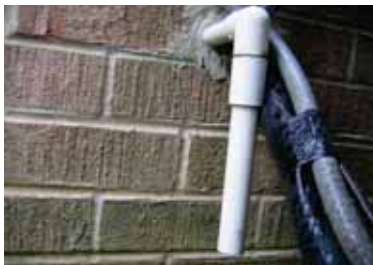
The condensate discharge tube is not extended far enough away from the house foundation.

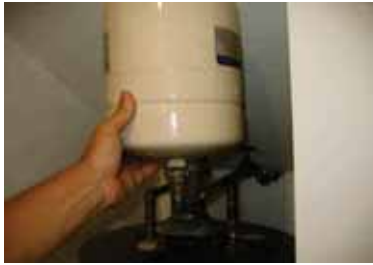
The water line has an expansion tank installed on it. There is a back-flow check-valve installed on the water supply line coming into the house. This back-flow valve prevents water from flowing back out to the street, and makes the plumbing system a closed water system. When the water heater makes hot water, the water in the system expands. The expansion of the warm water increases the pressure on the homes water pipes. The expansion tank absorbs the extra pressure. The action of the expansion tank reduces knocking of the pipes and wear and tear on the faucets and shut-off valves in the home. Good.

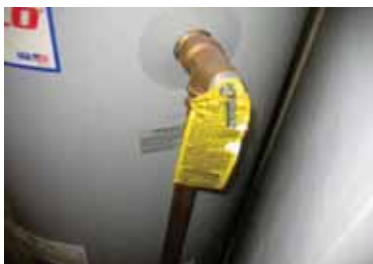
The water heater is equipped with a pressure-temperature relief valve. The pipe is extended to the floor. For safety. Good.

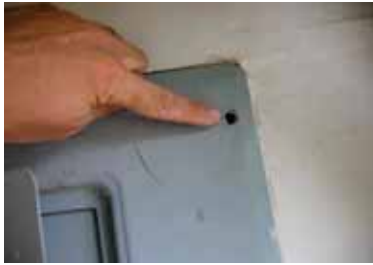
Missing screws at the cover.

There are open twist-outs at the panel cover. Potential safety hazard. A cover or cap at the open space where a breaker used to be installed is needed. If you stick your finger through the opening, electrocution is likely.

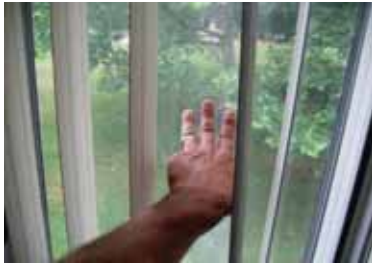
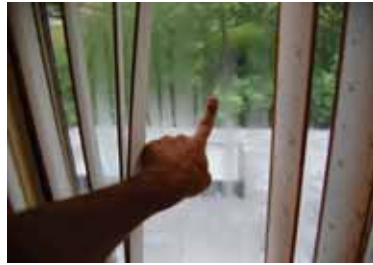
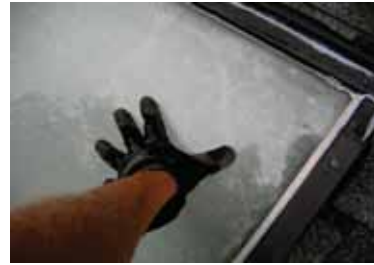
There are 5 fogged windowpanes. Lost seals. Replacement of the insulated windowpanes is needed. Located at the two rear skylights, and 3 panes at the rear bedrooms.

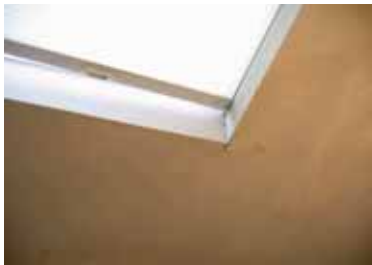
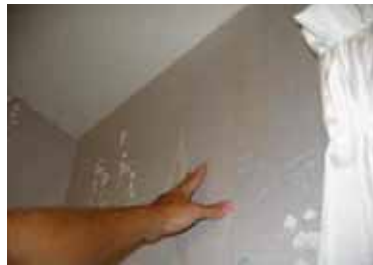
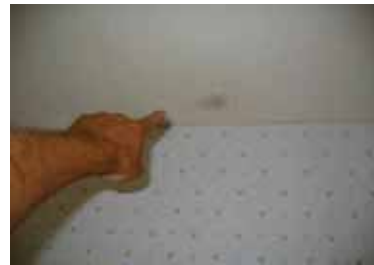
Water marks on the ceilings - may be from the roof above. Ask seller about the water stains and prior roof leaks. Located below the skylights, and other areas.
