THE HOME INSPECTION REPORT

07070502B - Paul [REDACTED]

[REDACTED] **Avenue, King Of Prussia, PA 19406**

7/5/2007 12:30 pm to 3:30 pm

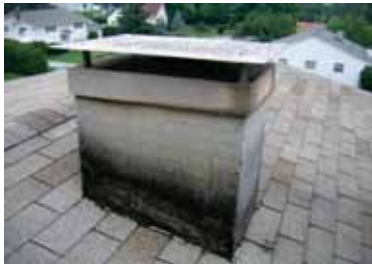
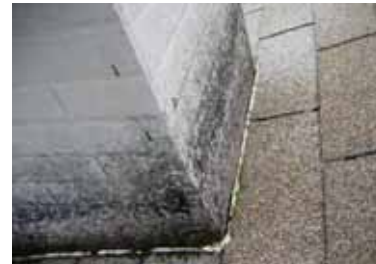
There is a metal chimney liner inside the stack. Metal chimney liners, usually of stainless steel or aluminum, are primarily used to upgrade and repair existing chimneys. These liner systems are U.L. tested and listed, and if properly installed and maintained are extremely safe and durable. Stainless steel is suitable for woodburning, gas, or oil applications, while the aluminum is an inexpensive alternative for certain medium efficiency gas applications only. It is usually required that high temperature insulation be used in conjunction with the liners for safety and performance considerations.

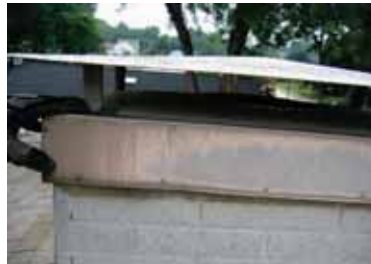
Heating System Chimney Lined Chimney

The chimney exterior walls appear to be in acceptable condition.

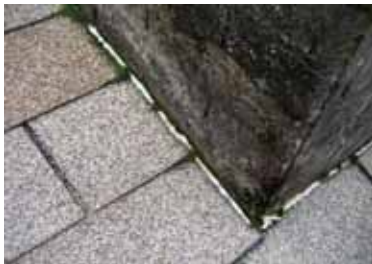
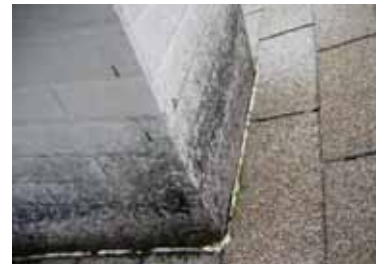
The chimney flashing where the stack meets the roof is heavily sealed. Sealant is not permanent. May indicate a chronic problem with water penetration here. Correction and further evaluation is recommended.

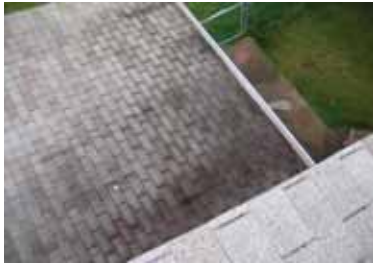
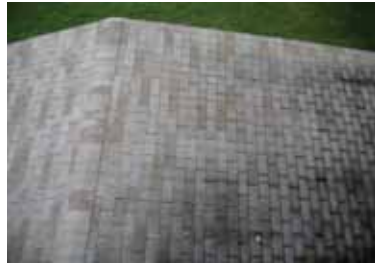
The exact age is undetermined. I would guess between 15 and 20 years. Ask seller about exact age and warranties.

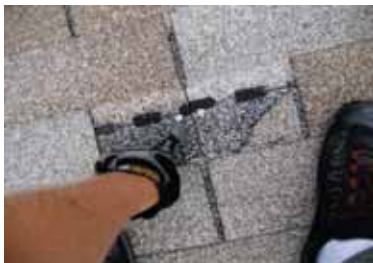
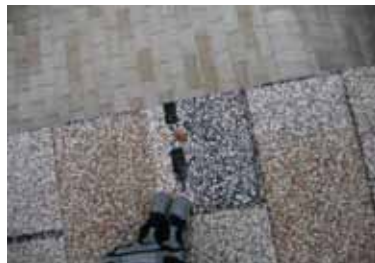
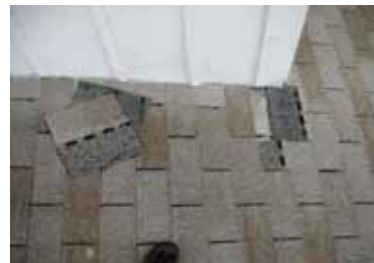
There are five cracked and missing shingles. Prone to leaking. Four located at the main house roof; the other at the front corner of the garage roof. Correction, repairs, and further evaluation by a professional roofer is recommended.

The asphalt shingles at the end of their service life expectancy. Old shingles. May not be reliable. Replacement of the shingle roof may likely be recommended by a professional roofer.

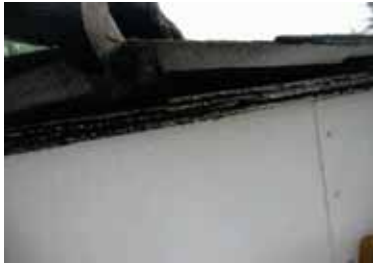
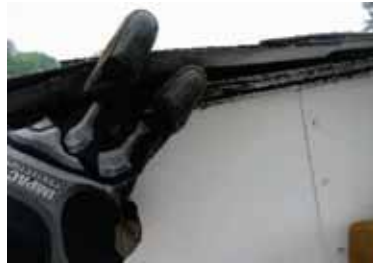
Two layers of shingles are visible. Not recommended because it adds weight to the roof framing, reduces life expectancy, and requires maintenance of the flashings. Sometimes there are flashing problems because of the two layers of shingles.

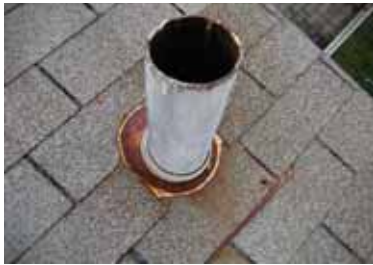
The flashing around the vent stack coming through the roof appears to be in fair condition.

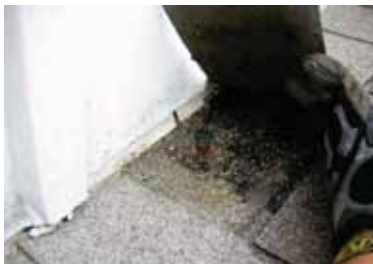
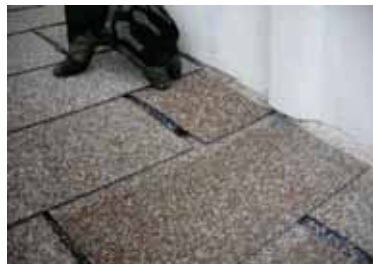
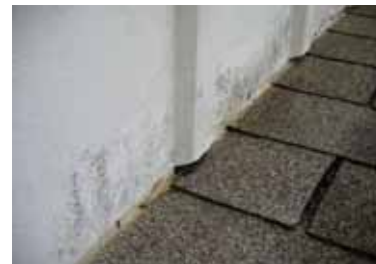
The flashing where the roofing shingles meet the house wall is in poor condition. The flashing is not installed with the top layer of shingles. Probably with the lower, older layer. The missing flashing leaves the edges of the top layer of shingles open to water penetration along the wall. Correction by a professional roofer of roof-to-wall intersection and flashing is recommended.

The roof vents have been coated with roofing sealant, which is indicative of either an unprofessional installation or a sloppy, improper repair of a water leak. Recommend asking the seller about prior leaks at the roof vent flashings.

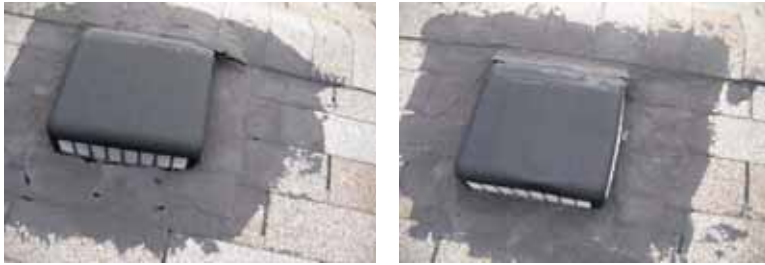
There are soffit vents installed at the eaves.

There are passive roof vents installed on the roof.

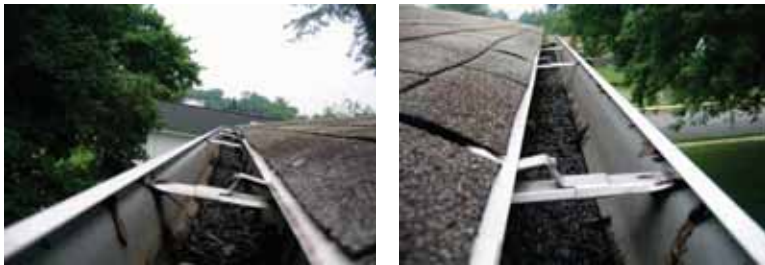
Dirty gutters. Debris and leaves inside them. The gutters need to be cleaned and serviced to drain properly.

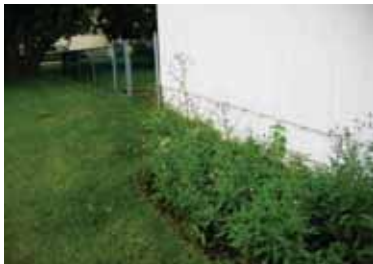
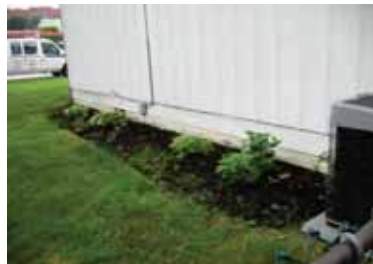
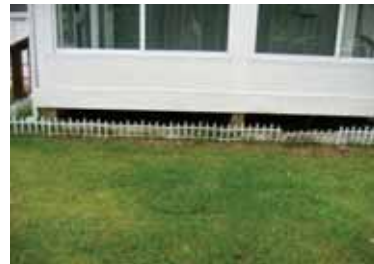
Grading and drainage is either negative or neutral adjacent to the structure's foundation, and may cause moisture or water penetration. Ideally the grading and hard surfaces should slope about 6 inches over the first 10 feet away from the house foundation.

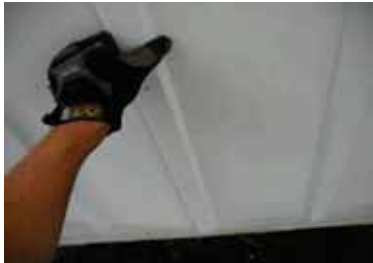
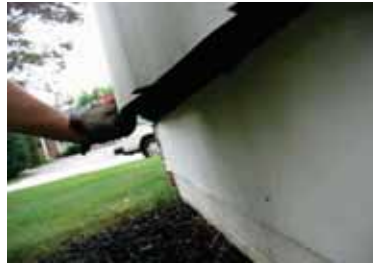
The aluminum siding appears functional. But old and weathered paint. Some places, the paint is in poor condition.

We moved around the house exterior several times, inspecting the aluminum siding on the exterior of the house. Checked for loose, missing, split, and dented panels. There are dents.

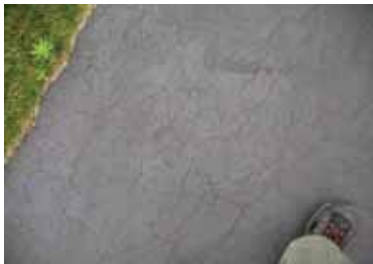
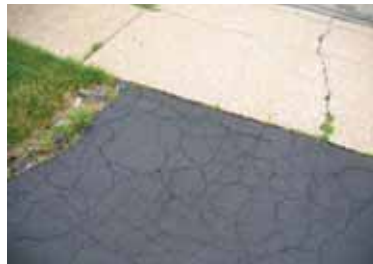
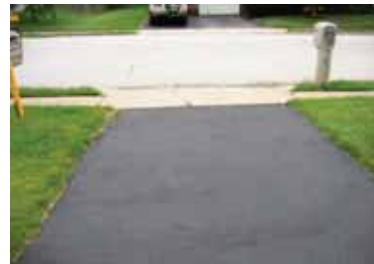
There are cracks and damage to the asphalt driveway in areas. Common repairs are needed. Could be patched yourself or by a professional.

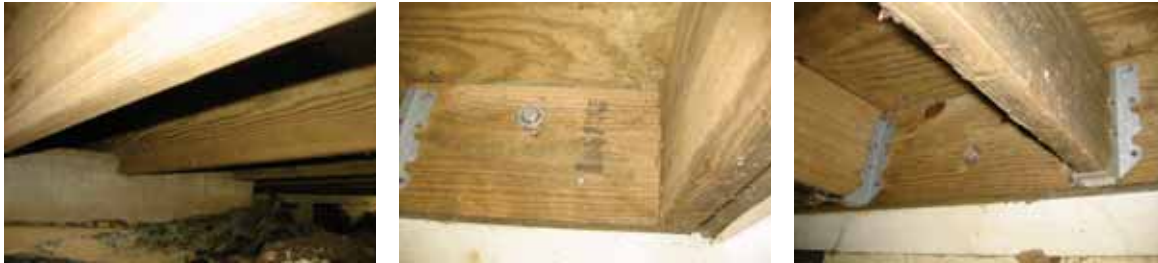
The deck structure appears functional. No major material defects were apparent.

I was unable to access underneath the deck. Inspection restriction.

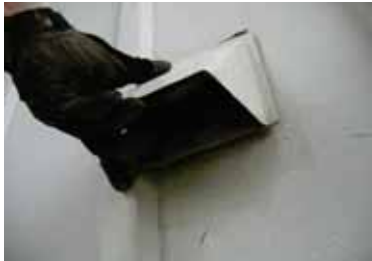
The dryer exhaust hood appears functional. No damage to hood or damper. No major lint build-up. We recommend inspecting and cleaning the dryer's exhaust pipe every year.

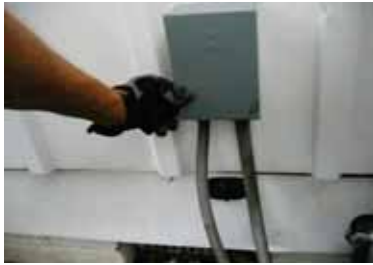
There is an electrical disconnect near the exterior condenser unit.

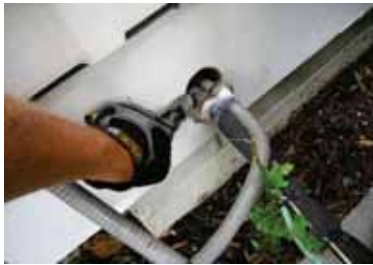
The hole through which the refrigerant line passes into the house needs sealed or patched.

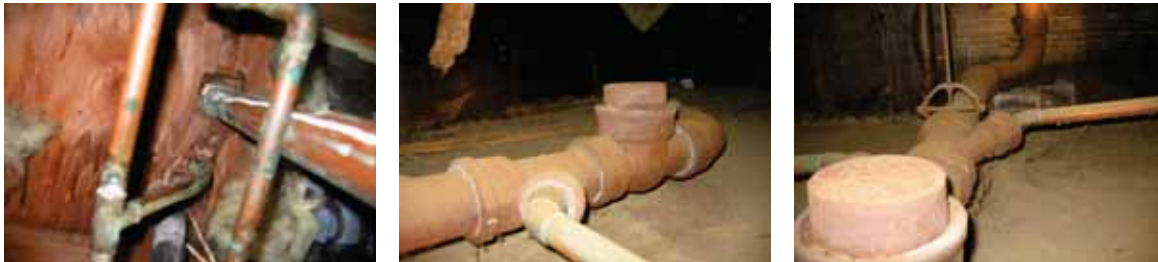
Visible portions of the drainpipes are cast-iron.

Visible drain pipes are made of copper.

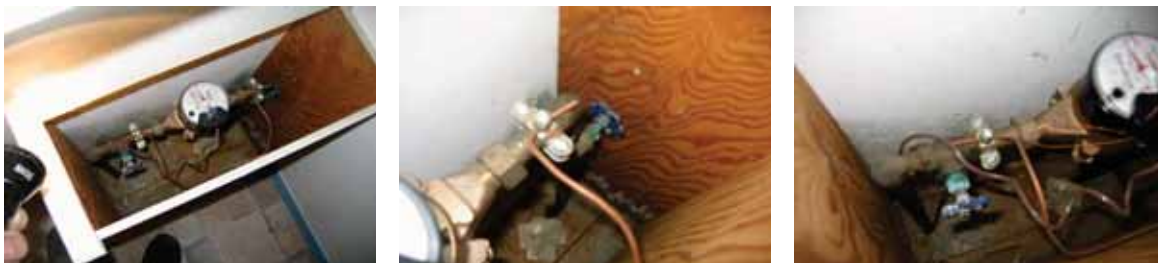
The main water shut-off valve is located in the small kitchen closet.

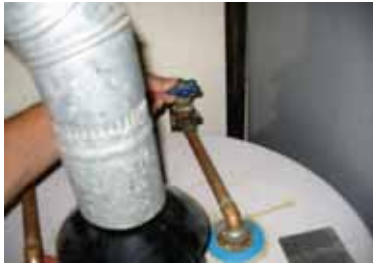
The water shut-off valve to the water heater tank is installed. Not leaking. This valve turns off the cold water supply to the tank. Good.

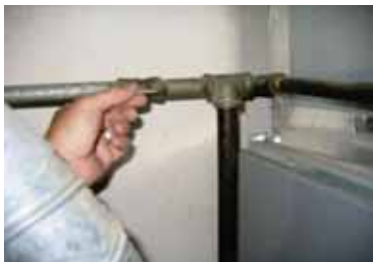
The gas shut-off valve at the water heater is installed within reach of the tank. This valve turns off the gas supply to the tank. Good.

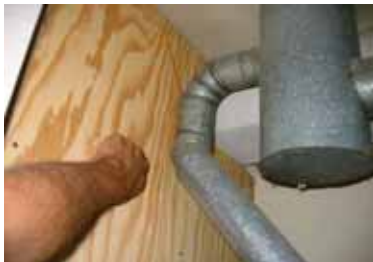
The vent pipe is too close to combustible material. Fire hazard. Should be repaired. A single-walled vent pipe should be six inches away from any combustible material, and a double-walled vent pipe should be one inch away.

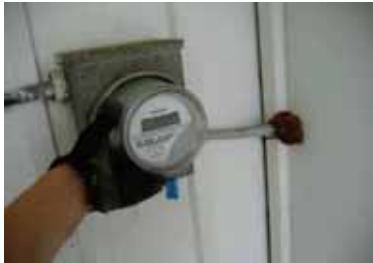
There is one electric meter.

The meter is located at the rear of the house.

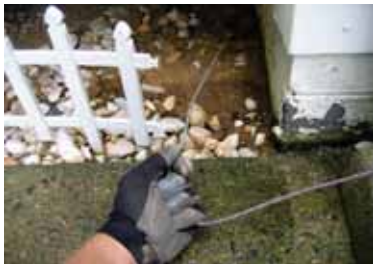
There is a grounding wire visible outside. Good.

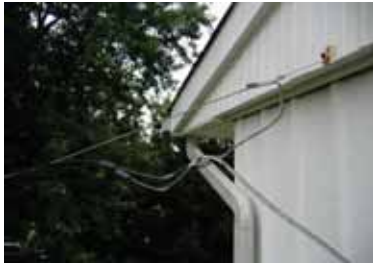
The main electric service line is inadequately supported to the side of the house. Loose. Missing straps.

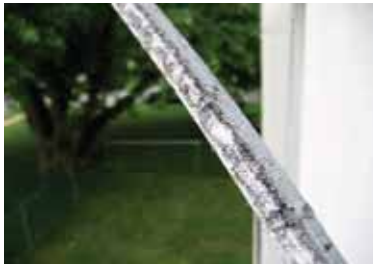
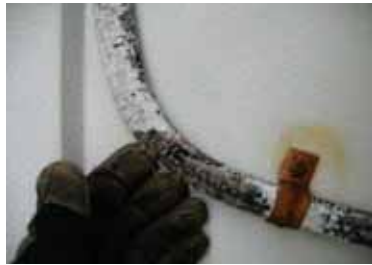
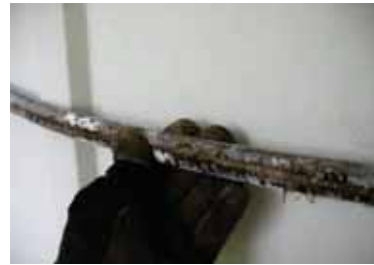
The main electrical service line has a damaged and worn out protective sheath. This sheath may allow water and UV radiation to penetrate the lines. Posing an electrical hazard. Further evaluation and replacement of the electrical lines is recommended.

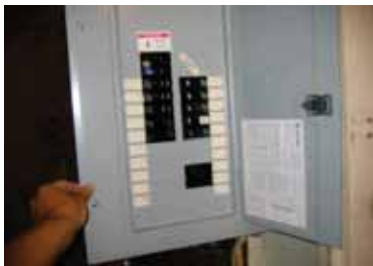
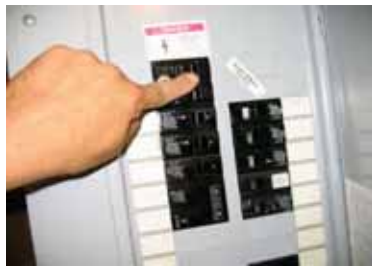
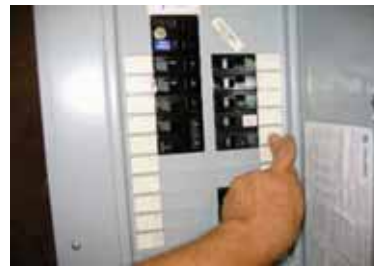
The main panel is located in the garage.

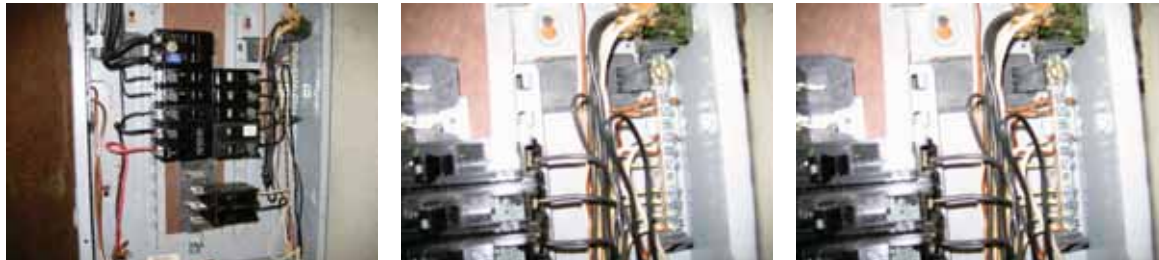
Modern Romex wiring is visible. Good.

The residence has old, cloth-covered, tin-coated, wiring. Indication of the house's age.

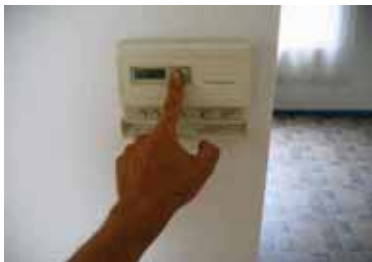
There is a thermostat located on first floor.

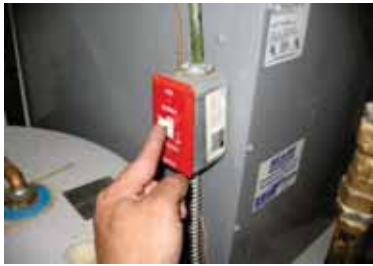
There is an electrical shut-off switch located on the side of the heating system.

The electrical shut-off switch functioned. Good. I would use this switch when inspecting the air filter.

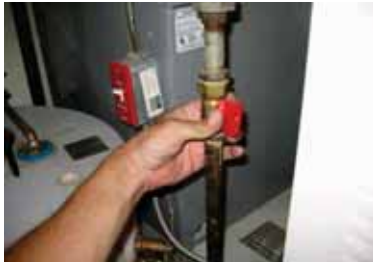
There is a gas shut-off valve near the heating system. Good.

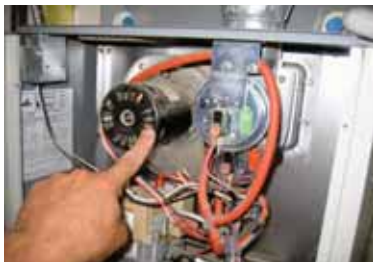
There's a lot of dust lying on the burners. Indication of delayed or poor maintenance.
The draft fan has a rattling sound in it when operating.

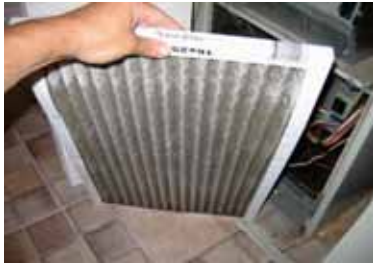
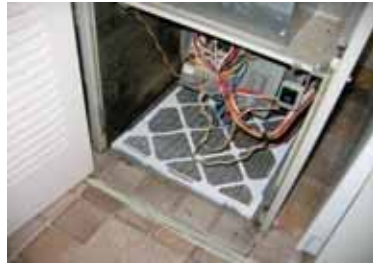
The air filter is disposable and dirty. Replace filter and check every 30 days. Replace when necessary.

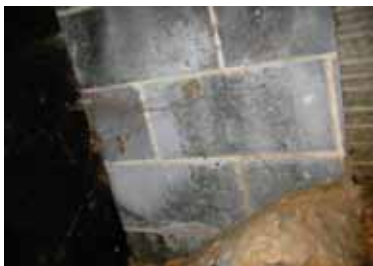
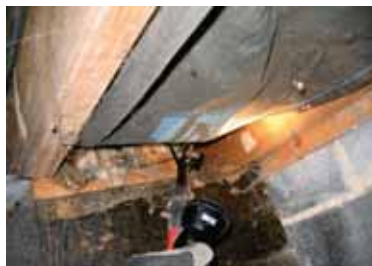
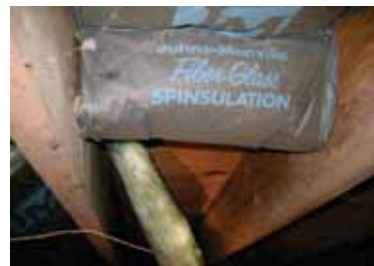
Crawlspace Restrictions

There's insulation hanging from the ceiling of the crawlspace. Inspection restriction - blocking components that I can not see.

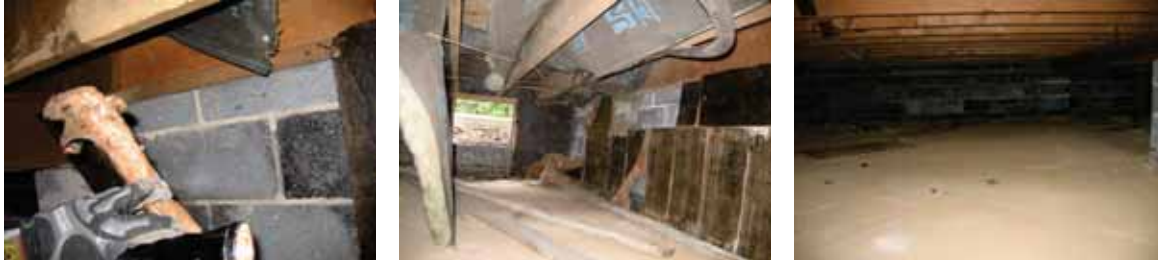
Concrete Block Foundation

The concrete block foundation of the structure appears to be functional. Readily accessible areas were inspected. There are no indications of major material defects apparent.

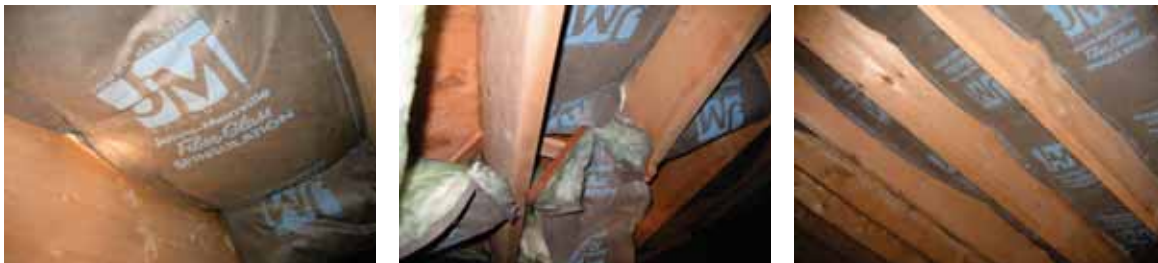
Some pieces of insulation are hanging or have fallen from between the floor joists.

The insulation that is attached to the floor joists (as seen from the crawlspace) is installed upside down. The paper vapor barrier is supposed to be applied towards the living space. As indicated by the manufacturer's label on the insulation itself. Prone to condensation and moisture problems developing. Correction and further evaluation is recommended.

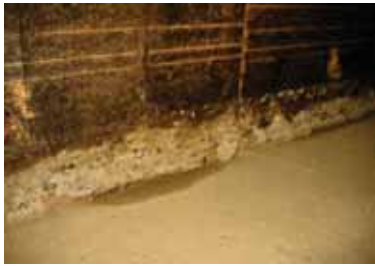
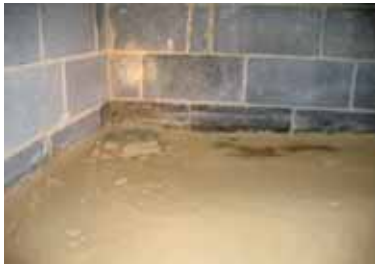
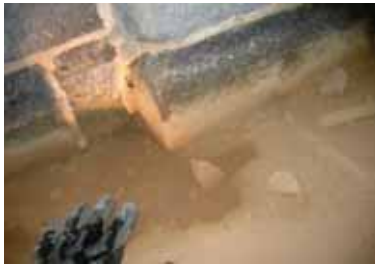
There are visual signs of water penetration. Located at the perimeter of the crawlspace foundation. Ask seller about water problems.

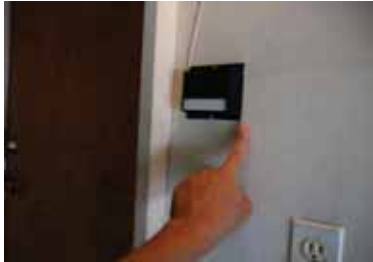
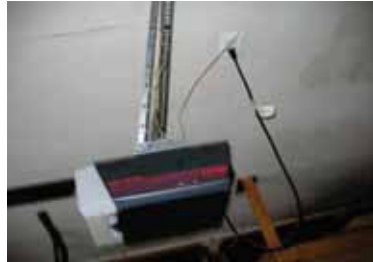
Attached Garage Garage Door Opener

The garage door opener is functional. With functional infra-red sensors.

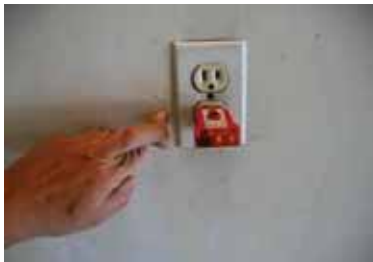
The receptacles in the garage should be upgraded to have GFCI or ground-fault protection, which is required by current standards and is an important safety feature.

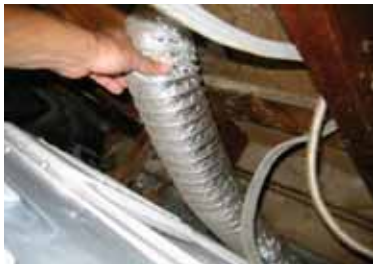
The dryer vent is a flexible foil type that traps lint more easily than a smooth metal type, which can compromise the performance of the dryer and can facilitate a fire. Replacing the vent pipe with smooth metal is recommended.

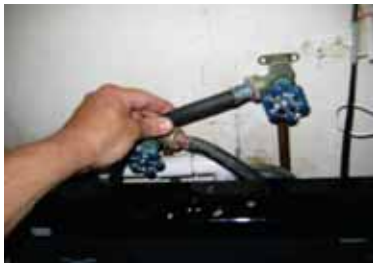
Rubber hoses should be replaced with more reliable ones - pressure-tested hoses. Such as stainless-steel, braided mesh hoses.

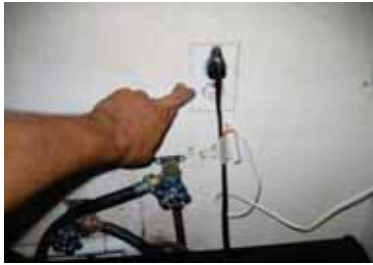
Missing GFCI protection at the electric receptacles near the washer.

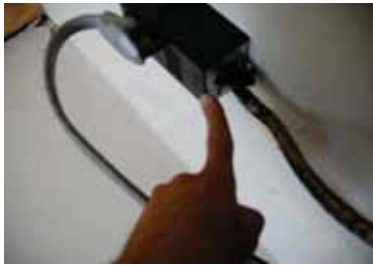
Installed on the wall. Currently plugged in and being used. Missing clamp at the bottom of the box.

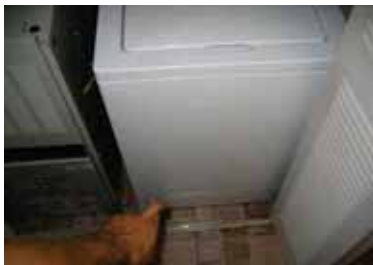
There's no water leak catch pan installed under the clothes washer. To catch leaks before causing water damage. Correction by a plumber is recommended.

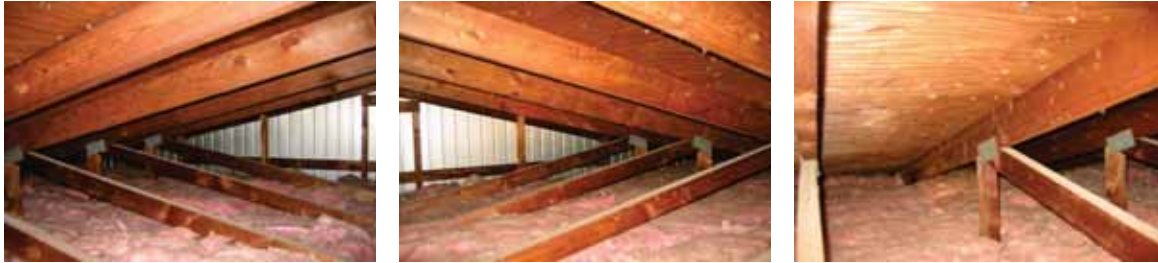
Primary Attic Space Method of Evaluation

We inspected the attic by entering it. But there is no flooring, and the insulation is covering the joists. I am unable to safely move all around the attic space completely. Inspection restrictions.

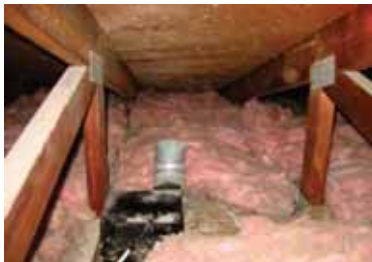
The bathroom fan exhausts into the attic. This has not been properly installed. The fan should be vented to the outside properly. Either through the roof or through an outside wall. Not to the soffit vent at the eaves of the roof. Currently the fan vents moisture into the attic space. This moisture can reduce the R-value of the insulation. The moisture can contribute to mold and mildew growth on the underside of the roof sheathing. Correction of the bath fan which is exhausting into the attic is recommended.

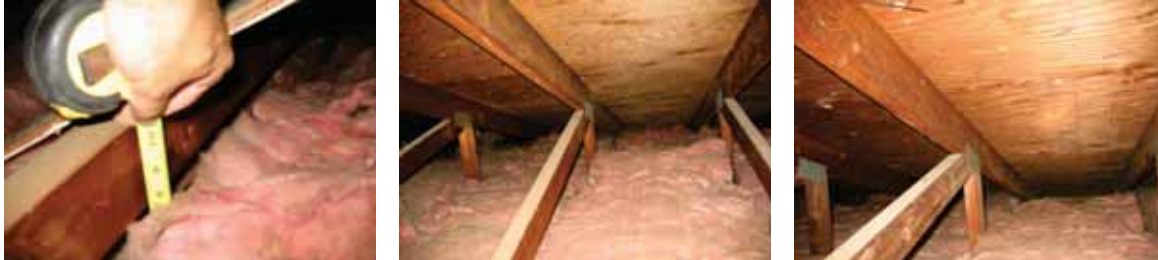
Type of Insulation

Fiberglass batt insulation is installed. Fiberglass is a man-made product that is composed of natural ingredients such as sand and recycled products such as window glass and bottles. The ingredients are melted and spun to create small strands of fiberglass that together form "glass wool". Fiberglass insulation has been used since the 1930s and is now the most widely used home insulator.

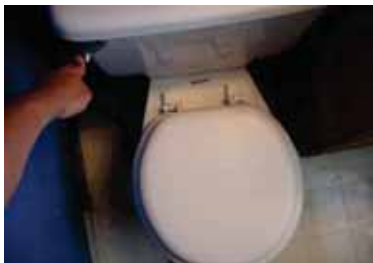
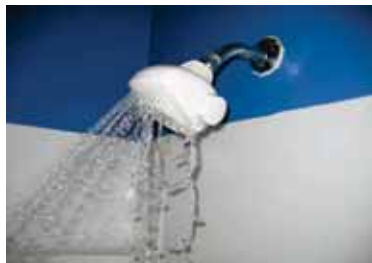
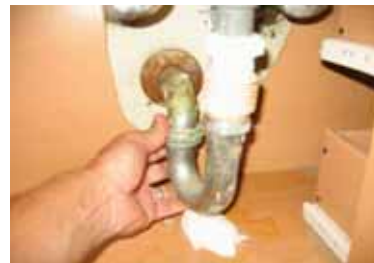
2nd Floor Full Bathroom **No Recommended Service**

We inspected the bathroom, and found no major defects. Toilet flushed a couple times. Running water at the sink. Sink drained. The tub/shower functional. No active leaks.

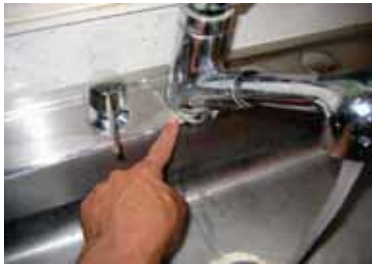
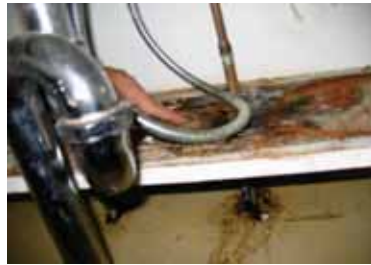
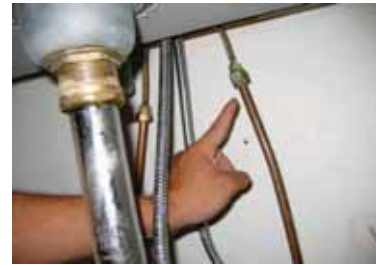
The faucet leaks around the stem while in use, and at the water supply line fitting below the sink. It should be repaired or replaced.

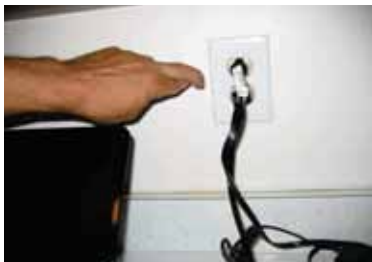
Missing GFCI-protection at the kitchen counter receptacles. All of the countertop and island receptacles should be upgraded to have ground fault GFCI protection, which is mandated by current standards and is an important safety feature.

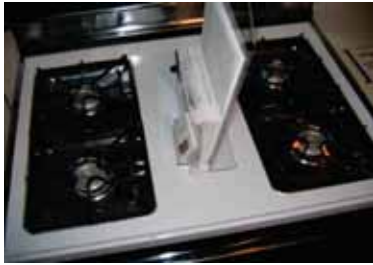
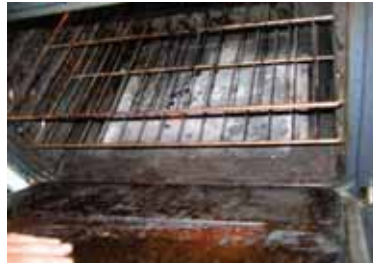
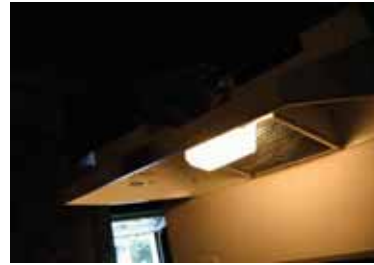
Gas Cooktop

The gas cook top is old, so it will obviously not be as efficient as a newer model and should not be expected to last indefinitely.

The gas cook top elements turned on.

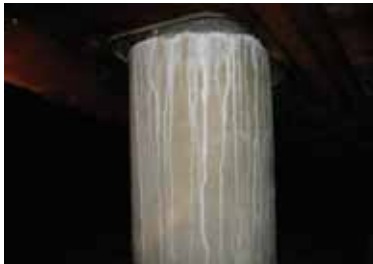
Apparent asbestos material was found at the property.

We recommend having a professional contractor trained in the methods of safety handling asbestos to further inspect for wear or damage such as tears, abrasions, or water damage. Repair or removal may be recommended by the professional.

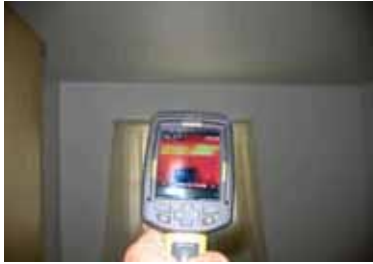
Missing insulation above the bedroom windows.

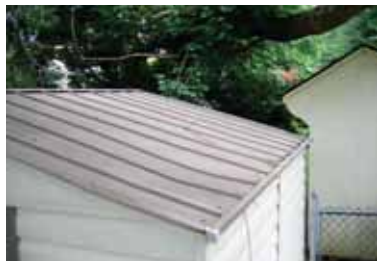
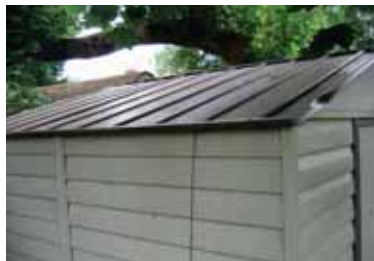
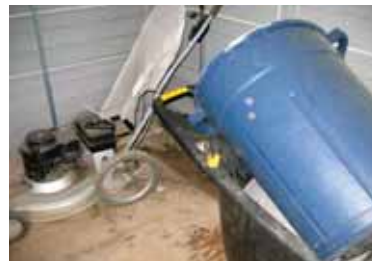
Other Structures Shed Structure

The shed in the yard appears functional.
